Technical Report REMR-OM-16
September 1995

REMR Management Systems—Navigation and Reservoir Structures, Condition Rating Procedures for Concrete in Gravity Dams, Retaining Walls, and Spillways

by *Rupert E. Bullock*
Engineering Consultant

Stuart D. Foltz
*U.S. Army Construction Engineering
Research Laboratories*

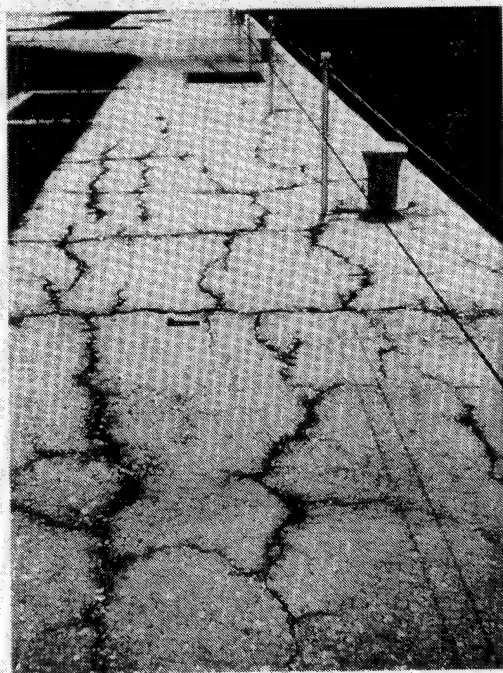
Fig. A.1.6d—Pattern cracking (alkali-silica reaction)

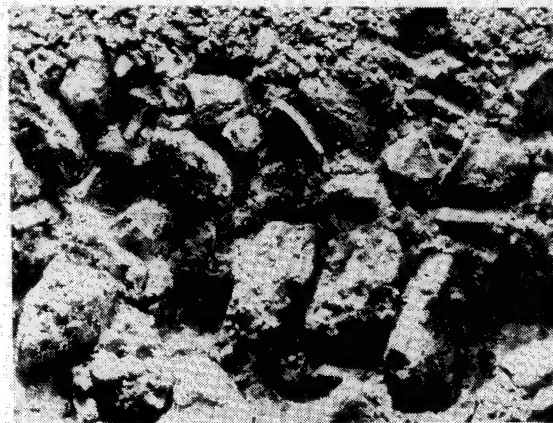
Fig. A.2.3—Cavitation damage

Cavitation (category 32). Cavitation results from the collapse of vapor bubbles in flowing water and is generally caused by high-velocity flow over abrupt changes in surface alignment. Cavitation causes additional changes in alignment. To prevent further damage, repairs should be made promptly and the cause of the damage should be eliminated. Deduct values from Table 4 are used. Measurement should be at the point of deepest cavitation.

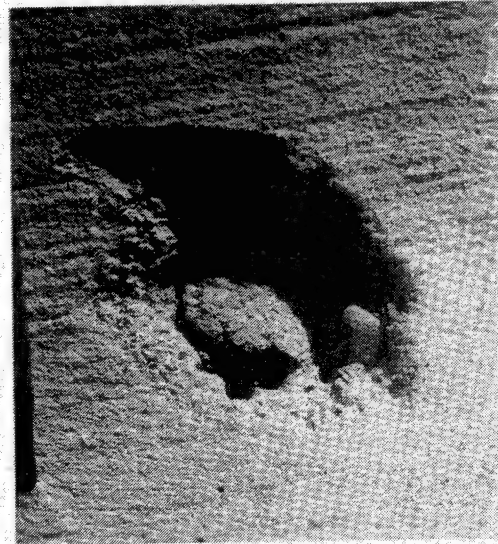
*Fig. A.2.19—Popout*

Popouts (category 34). Popouts generally are caused by freezing of saturated porous aggregate particles but may also result from alkali-aggregate reaction. They are more aesthetically offensive than structurally serious.
